# Dam repaired, system optimized

**Successful rehabilitation of the dike between the two filters: optimal operation restored!**

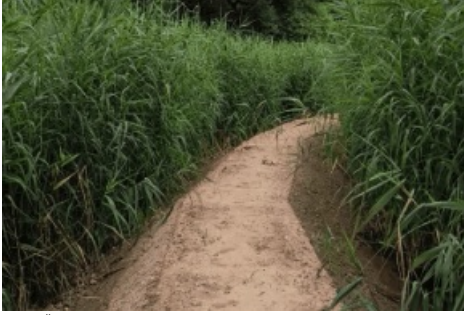
During the last mowing and maintenance operation, a failure was detected in the central separation between the two filters. This dike, which had partially subsided, was causing continuous overflows from one filter to the other, compromising the proper functioning of the installation.

To address this issue, rehabilitation work was carried out in June to rebuild an effective separation between the two filters.

Thanks to this intervention, the overflows have stopped. The system is now operating optimally, ensuring greater efficiency and long-term durability.
